OPS Briefing

January 13, 2014

**Air Monitoring Location/Data Map - 1/12/14 - 14:20 hours
Charleston, WV Chemical Leak - Etowah, West Virginia**

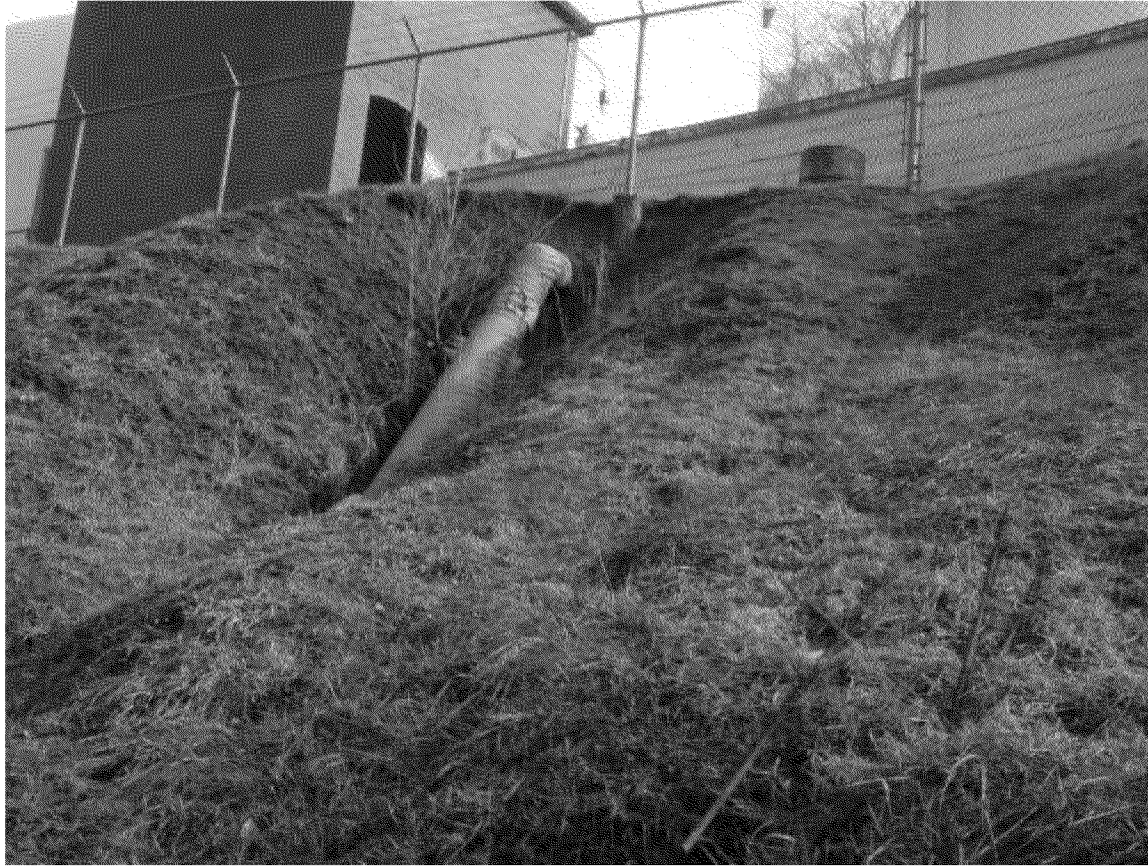
Storm drain below the second containment of tank farm

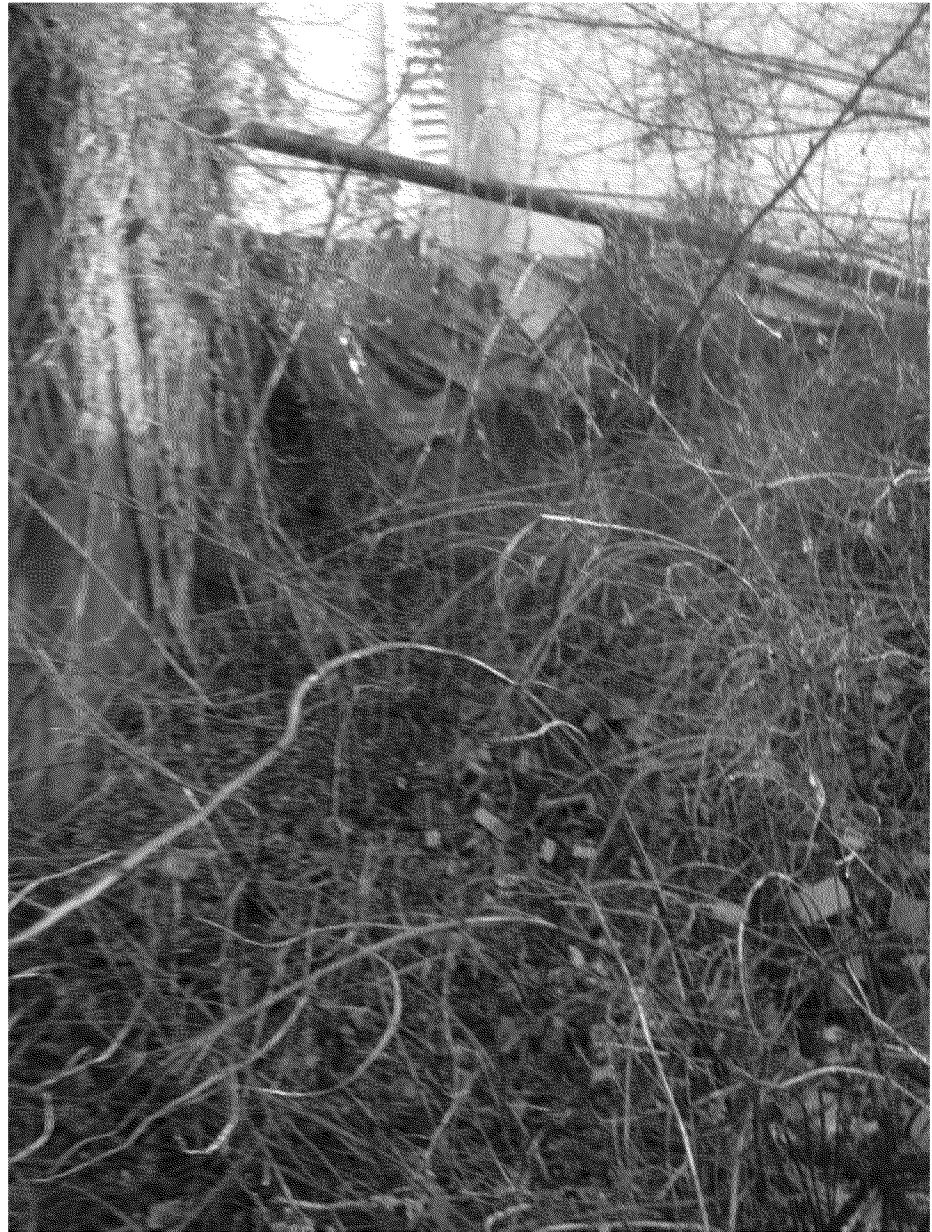
Example of Fill below Tank Farm

The yellow brick seen in this picture is just one layer of fill used.

- There is a layer of red brick from demolished buildings
 - Some tile from buildings are used
 - The secondary containment does have a clay liner below the fill and gravel layers
-
- Freedom Industries will be drilling two holes to look at what the layers of fill are specifically and the depth of each, once the issue with marking gas lines is resolved.
